# COMPOSITES FOR REINFORCEMENT OF DAMAGED METALLIC AIRCRAFT WINGS

D. Karuppanan, R.S. Rawat, H.V. Ramachandra, D. Saji and Byji Varughese  
Advanced Composites Division  
CSIR National Aerospace Laboratories  
HAL Airport Road, Post Box No. 1779  
Bangalore-560 017, India  
Email : karups@nal.res.in; saji@nal.res.in

*Advanced composites, because of their inherent directional properties and ability to take complex contours are ideally suitable for repairs even in aged metallic aircraft structures. The composite materials can be suitably tailored to suit the strength and stiffness requirement at location of the damage on the parent structure. The laminate patch can be bonded to the structure. This avoids the use of large number of fasteners that are required for repair with metallic repair patch. A composite patch repair has been carried out on a military aircraft wing. The skin and the spar flange near the landing gear part were cut in order to gain access to a loosened bolt. With a request from HAL (Nasik), National Aerospace Laboratories (NAL) has taken the responsibility of designing and realizing composite repair at the damaged locations. The geometry and lay-up of the patches

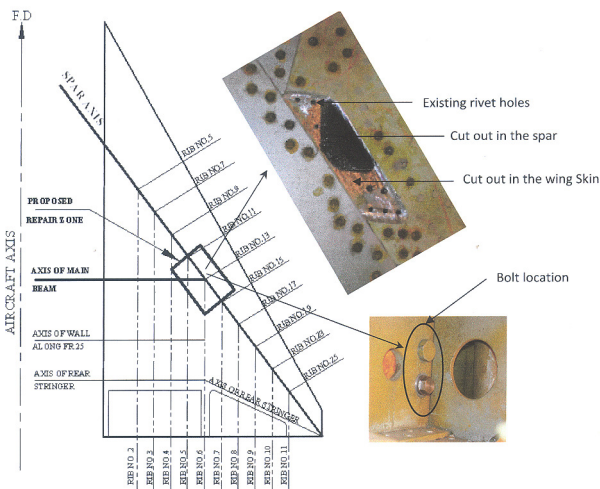
In the present case, the military aircraft main landing beam and spar web is connected by means of bolt and nut. Due to its long service and heavy landing these bolts were loosened. During its overhaul maintenance, the bolt loosening problem was identified. Due to inaccessibility to reach the loosened bolt, the wing skin and spar flange is cut at bolt location. Fig.1 shows the repair location with wing skin and spar flange cut out. Since these damages are very close to the fuel tank zone, the conventional metallic patch repair is not advisable. Hence, Carbon Fiber Reinforced Plastics (CFRP) patches are used to reinforce the damaged wing structure. The spar flange cut out is reinforced by CFRP filler patch, using hybrid bonding technique. The filler patch size is derived based on cut out width and existing rivet locations. Few existing rivet holes are used for mechanical fastening. The wing skin damage is reinforced using CFRP external patch, which is designed to take more load at cut out zone and gradually distributed in all the directions. Fig.2 shows the external patch location with internal construction of the wing. The external patch is bonded over the wing surface using room temperature curable adhesive by vacuum bagging technique. The bonded region is qualified by Ultrasonic 'A' scan (NDE) method.

Fig.1 Wing Repair Zone with Skin and Spar Flange Cut out

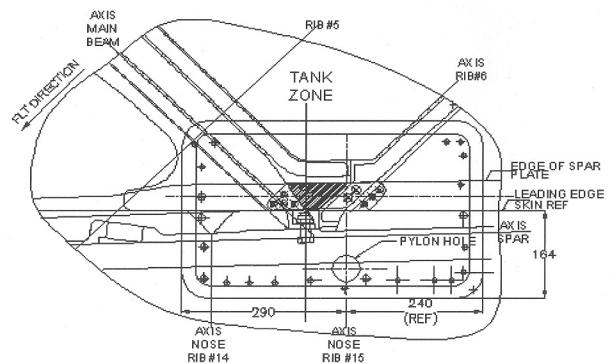
Fig.2 Interna Construction of the Wing with External Patch

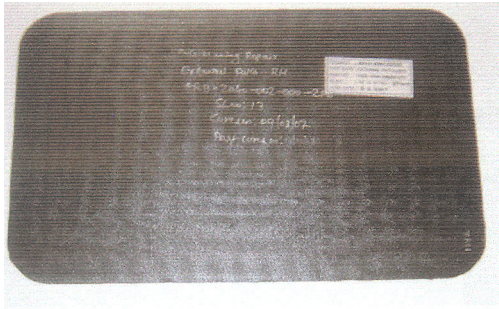
Fig.5 CFRP External Patch

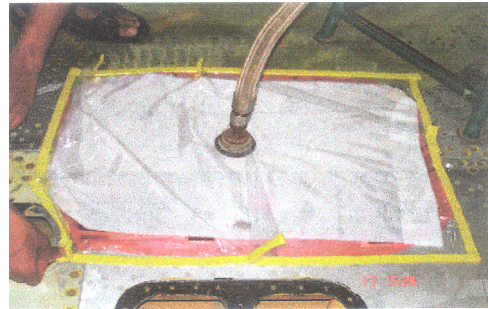
Fig.8 Vacuum Bagging on the Wing Surface

Figure 8 shows the vacuum bagging over the wing surface and Fig.9 shows adhesively bonded external patch on the wing with pylon hole is blocked with dissolvable material. All pilot holes are opened and reamed to the actual rivet size. The various diameter rivets are installed at required position with interface sealants [8]. Fig.10 shows the completely repaired composite patch on the wing surface.

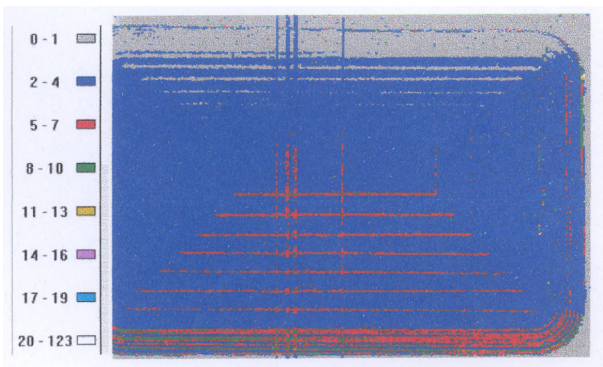
Fig.6 Ultrasonic 'c' Scan Plot of External Patch

The most important in the manufacturing of composite patch is the process planning. All process parameters need to be maintained as per quality requirements and some of the process variables need to be inspected. The filler patch and external patch are fabricated as per the design lay-up sequence in respective mould and they are vacuum bagged and cured as per material manufacturer's recommendation. Temperature cycle is monitored and controlled using thermocouples at the time of curing. Cured parts are post cured as per specified post cure cycle. Fig.5 depicts, how the external patch looks with aerodynamic profile and also clearly visible the layer drops on the surface of the patch. Developed composite patches are qualified by Ultrasonic 'C' scan which scan plot was shown in Fig.6. The mechanical properties of the process are checked by using the traveler coupon which is cured along with patches. The patches are qualified in all aspects as per Aircraft Design Standards (ADS) and accepted for repair of metallic wing.

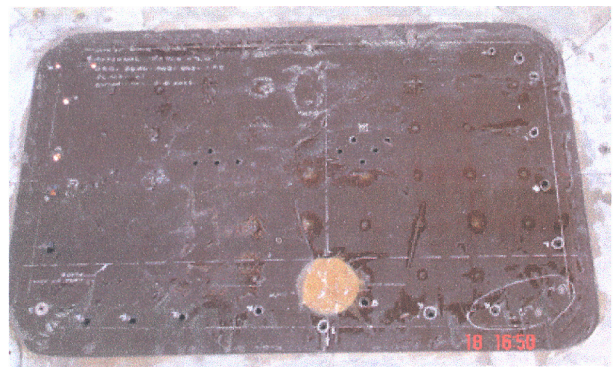
Fig.9 Adhesively Bonded CFRP Patch

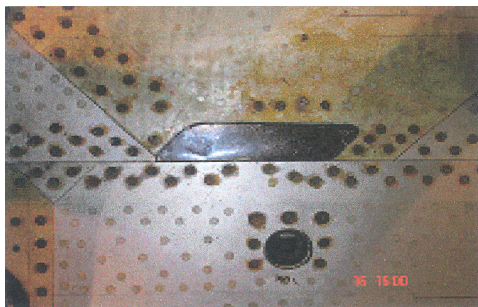
Fig.7 Filler Patch Bonded on the Wing

Filler patch is matched in the cavity, where the wing skin has been cut to the shape of parallelogram with corner radius. While matching the filler patch, few pilot holes are transferred from the spar plate. Fig.7 shows the filler patch installation on the wing cavity. After matching, both the spar plate surface and filler patch bonding surface have been prepared for adhesive bonding since CFRP patch has

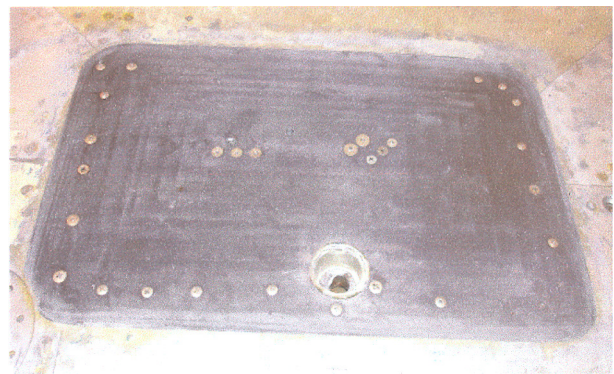
Fig.10 Repaired Wing
