## USE OF POKE-YOKE FOR RIGHT MANUFACTURING AND INSTALLATION

Appasaheb Malagaudanavar; Yogendra Singh and Narender Singh  
 Transport Aircraft Research and Design Centre (TAD)  
 Hindustan Aeroanautics Limited (HAL)  
 Kanpur-208 008, India  
 Email : gmaurdc.nsk@hal-india.com/appanna\_k@rediffmail.com

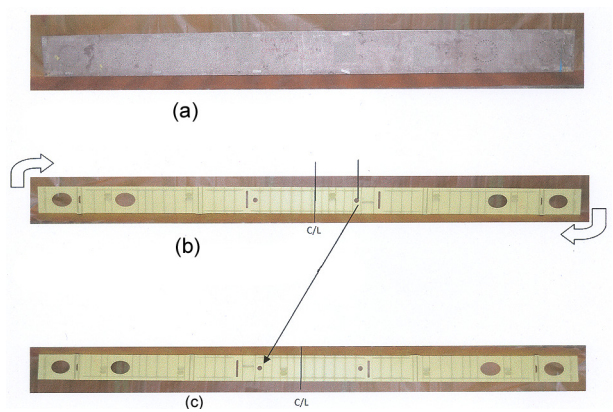
After producing about 90 numbers of aircraft, first time a defect was observed during production of rear centre spar. The part was fixed upside down during drilling on the drilling fixture. Hence the drilling pattern required on the upper side of the spar was done on the lower side and vice versa. This operation went unnoticed. During the next assembly, holes on the spar were transferred to the wing skin spar cap. At this time, the defect was noticed.

The defect was referred to the material review board. The Board deliberated on the reasons for the defect and what corrective actions should be taken. It was observed that, the drilling has been done by fixing the part upside down in the drill fixture (Refer Figs. 1a, 1b, and 1c ).

It was a clear case of the Drilling fixture being not able to prevent the loading of part in wrong orientation. Available stops on the fixture could not prevent wrong drilling. The error occurred due to part being symmetrical about its central axis. It was surprising that till such time there has been no mistake i.e. more than 90 parts were produced without mistake. The reasons for the error could be many but one single fact is that the fixture could not prevent wrong drilling. This errors lead to a considerable delay in production. The Board suggested for eliminating recurrence of such thing by either changing the fixture or some other means.

Fig.1a : Drilling Template for Centre Rear Spar;  
 1b : Correct Orientation of Centre Rear Spar  
 1c : Incorrect Orientation of Centre Rear Spar (Upside Down)

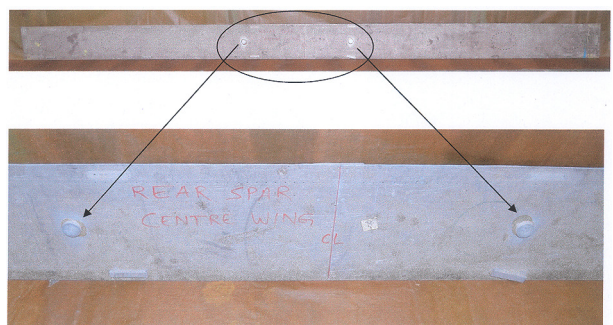
Fig.1e : Mating Plugs at Unsymmetrical Locations w.r.t. Centre Line of Spar

The tool was modified to have raised plugs at these locations. (See Fig.1e). This prevented the possibility of upside down fitting of the part for drilling.

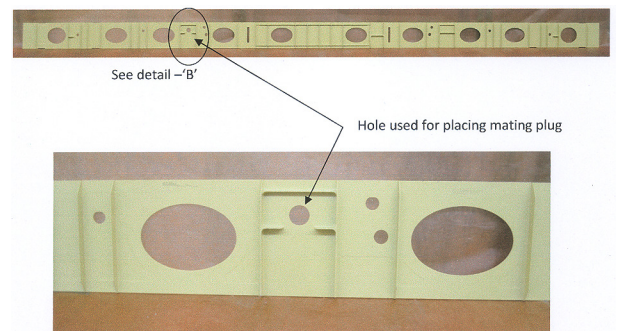
Fig.1d : Two Unsymmetrical Hole Locations Identified for Fitment of Mating Plugs

A team of Designers, shop representatives, quality and Tooling sat together and studied the problem with a view to provide solution. A close look at the part and the tool showed that, the tool can be modified to prevent positioning of part in wrong direction. The part has two holes of 52dia one at 470 mm from the centreline towards RH and another at 630mm from the center on the LH side. Exploiting this feature, if the tool has a corresponding mating plug at these locations, part simply cannot be fitted in wrong direction (Refer Fig.1d).

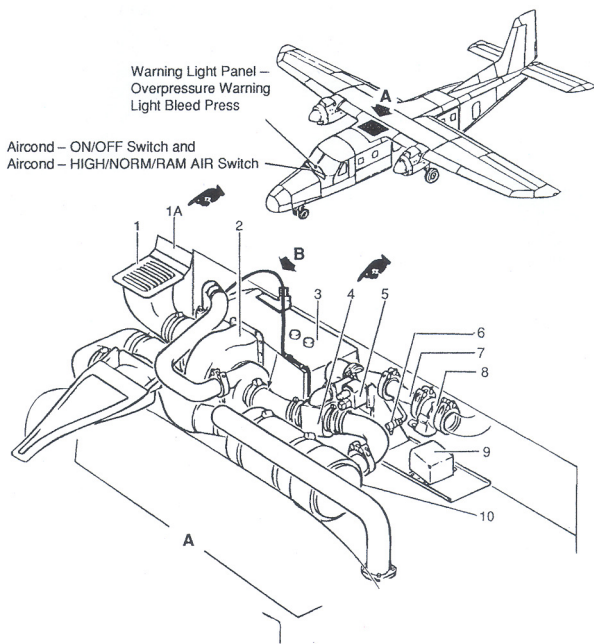
A gill is installed on the top surface of the fuselage using eight screws. ( Refer Fig.3a ) The gill serves as air outlet for cold air unit installed in the air-conditioning equipment bay. The gill is to be installed such that the gill flanges allow air from inside the cold air unit to get sucked by the outside air stream. One of the operators reported a problem of damaged flanges of the gill on one aircraft. He also reported that, the direction of the gill flanges was opposite as compared to other aircraft.

Brushing aside these thoughts, the problem was studied. It emerged that the gill can be installed in opposite direction because of biaxial symmetry of the installation holes (Refer Fig.3b) If anything can be installed wrongly, it will be. Murphy's Law never fails! This can result in air flow onto the gill flanges, the flanges of the gill are not designed to take up this aerodynamic load. This could result in damage of the gill flanges due to excessive air load. The damage to the component will also result in malfunctioning of the cold air unit.

Fig.3a : Installation of Gill Plate

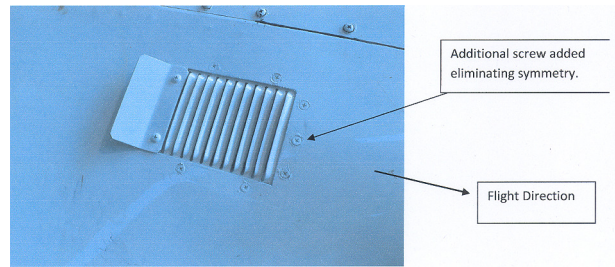
Fig.3b : Installation of Gill Plate : Post Modification

An additional fastener was introduced in the center (the same set of fasteners used), This resulted in use of all existing parts and also it ensured that the part cannot be installed wrongly(Refer Fig.3b).
