## FRETTING FAILURE OF TURBINE BLADES IN A TURBOJET ENGINE: A CASE STUDY

R.K. Mishra and K.S. Jayasimha  
Regional Center for Military Airworthiness (Engines)  
CEMILAC, Bangalore-560 093, India  
Email : rkmishra\_gtre@yahoo.com

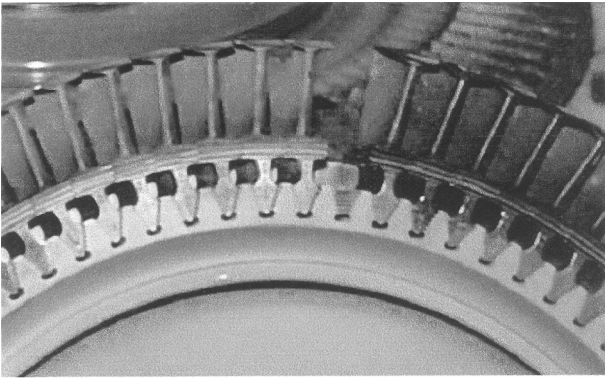
The engine is in service and during periodic boroscopic inspection of turbine rotor blades; cases of blade cracks and failure on fir-tree location are noticed. The details of these three cases are given in Table-1. These engines are withdrawn prematurely for detail investigation. As a precautionary measure, NDT crack detection checks are suggested on all engines at the earliest. One of the typical blade failure cases is shown in Fig.3.

Optical electron microscope examination has identified the failure mode as fatigue in all three cases. The cause of fatigue is determined as cyclic load arising from fretting and is due to the dimensional deviation in serration slots. Fretting damage generally occurs at blade and disc attachment surfaces at fir tree section, bolt flanges and shrink fit areas [3][4].

*Fig.3 Turbine Blade Failure : A Typical Case*

- To introduce a layer of compressive residual stresses in the vicinity of the surface that undergoes fretting fatigue. Methods such as shot-peening, cold working and laser shock peening may be followed.
- Coefficient of friction between the fretted surfaces to be reduced by introducing lubricants such as polytetrafluoroethylene, molybdenum disulphide etc.
- To increase the frequency of in-situ NDT check.
- To select efficient lapping tools and processes during lapping of blade fir-tree in the disk slot.

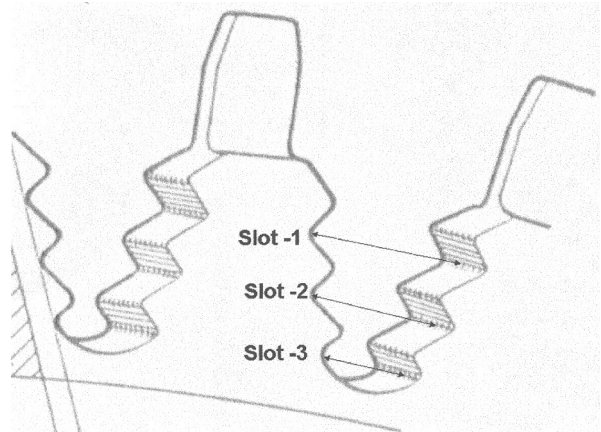
*Fig.4 Definitions of Disk Slots w.r.t Blade Serration*

There was no evidence of over heating of blades and disc. Tip clearances were within allowable limits. However, FPI confirmed the cracks on blade fir-tree serrations and non- uniform loading. Dimensional checks on the blade fir-tree serration sections have shown deviations from the overhaul limits which are presented in Table-2.

Blade Nomenclature	Slot-1	Slot-2	Slot-3
Acceptance Limits (mm)	5.316 +0.152	3.391 +0.152	1.468 +0.254
Case-1/Bld 1	0.127	0.107	0.305
Case-1/Bld 2	0.030	0.040	0.234
Case-2/Bld 1	0.102	0.097	0.304
Case-3/Bld 1	0.119	0.009	0.335
Case-3/Bld 2	0.102	0.104	0.343
Case-3/Bld 3	0.119	0.114	0.335

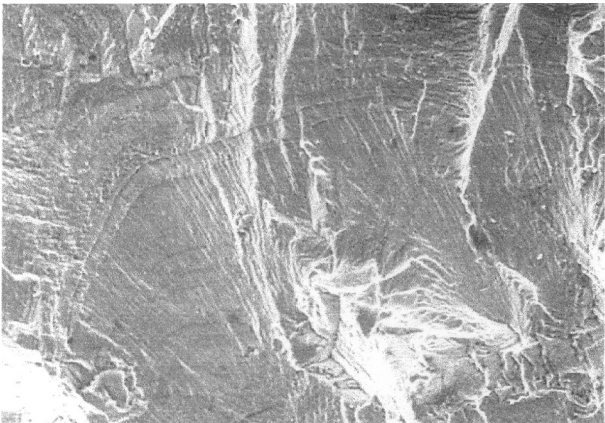
The microscopic examination has confirmed the failure as high cycle fatigue (HCF). The factographic picture is presented in Fig.5. Fretting scars were also visible in the slots of partial slip regime at the outer rim of the contact area.

*Fig.5 Factographic Picture of the Failed Blade Section*
