## DEFECT TREND ANALYSIS FOR A MILITARY TURBOJET ENGINE: CASE STUDIES

K.S. Jayasimha, R.K. Mishra, S.N. Mistry  
Regional Center for Military Airworthiness (RCMA) (Engines)  
Center for Military Airworthiness and Certification (CEMILAC)  
Bangalore-560 093, India  
Email : rkmishra\_gtre@yahoo.com

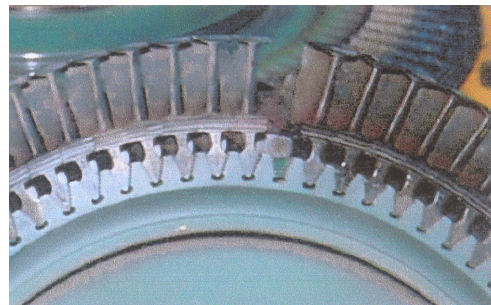
Cracks on turbine blade fir tree serrations are found in few engines during periodic crack detection checks at operating units. The cause for fir-tree crack was found due to be fretting fatigue resulting from non-uniform loading as shown in Fig.7 [3] [4].

Deficiency in lapping process and tear and wear in the blade serrations as well as disc slots have led to this failures. Strict adherence to serration/slot dimensional tolerances and proper lapping for to achieve 100% bedding were adopted to address this problem. This action has helped in avoiding engines to suffer blade cracks in future. As a precautionary measure, crack checks are introduced at regular intervals prior to engine overhaul.

Fig.7 Turbine Blade Failures

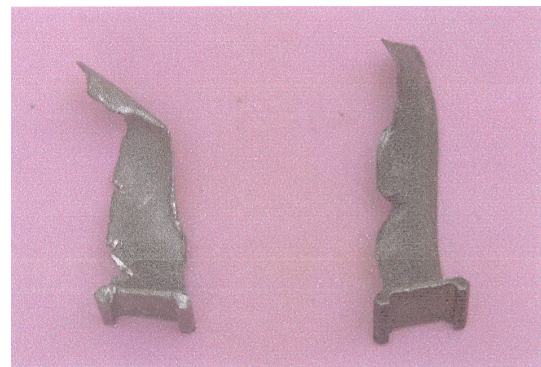
Though this is an isolated case, it is very critical from safety and operational point of view. Immediately after take-off, pilot observed a loud bang sound followed by rapid winding down of RPM and JPT and subsequently engine flame out.

In this incident, the compressor was severely damaged with its casing failed. All the compressor rotor blades made of aluminum alloy have failed in shear and do not show any fatigue. The casing has failed instantaneously

and does not show any progressive failure. The mutilated stator vanes are shown in Fig.8.

The rotor assembly including the turbine does not show any sign of movement and the bearings were intact without any signature of impact or excess loading. A drop in hardness on the turbine blades was noticed indicating momentary overheating. The flame tube nozzle guide vanes also indicated marks of oxidization and discoloration. The findings of the investigation led to confirm the compressor surge followed by flame out. However, the cause of compressor surge could not be ascertained precisely. The most probable reason for surge could be high angle of attack during climb and or excess inlet distortion, both going beyond the design limit. Further, it might be a result of incompatibility of inlet guide vane angle to the flight condition or mismatch of jet nozzle with throttle excursion [1]. However, insufficient flight data in the present case hindered in further investigation to identify any of these parameters responsible for the surge. The possibility of FOD also could not be ruled out which could have blocked the air passage causing a momentary imbalance in the stoichiometry. Advanced and intelligent surge detection and control mechanisms can be thought of to be introduced in the engine if feasible to address this problem [5,6,7].

Fig.8 State of the Stator Vanes Due to Surge
