NOVEL REPAIR SCHEME FOR THE EDGE DELAMINATED COMPOSITES

D. Saji* and S.C. Pradhan**

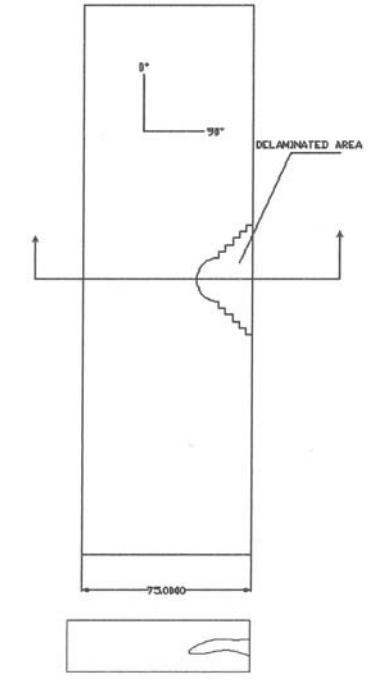
Fig.2 Typical Edge Delaminated CFRP Panels

(0.10mm thick) at the half and quarter thickness of the panel. Fig.2 represents typical edge delamination in the CFRP panel.
