## DEFECT TREND ANALYSIS FOR A MILITARY TURBOJET ENGINE: CASE STUDIES

K.S. Jayasimha, R.K. Mishra, S.N. Mistry  
Regional Center for Military Airworthiness (RCMA) (Engines)  
Center for Military Airworthiness and Certification (CEMILAC)  
Bangalore-560 093, India  
Email : rkmishra\_gtre@yahoo.com

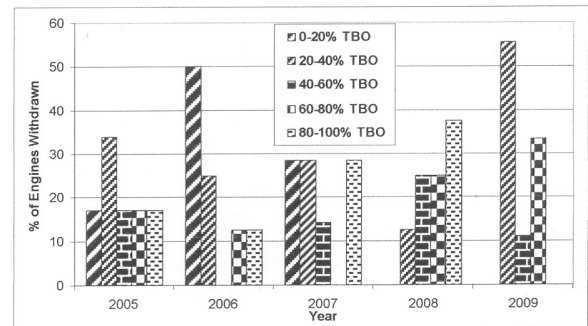
Fig.5 Year-wise Engine Withdrawals at Different Stages of TBO

Rotor imbalance, damage of rubber sealing during engine assembly and fuel pump/idle-max fuel settings at the overhaul unit have attributed to such defects. Taking appropriate measures at assembly stage and proper settings at test bench have made these defects reduced drastically. Year-wise defects and reduction of early stage withdrawals are shown in Fig.5.

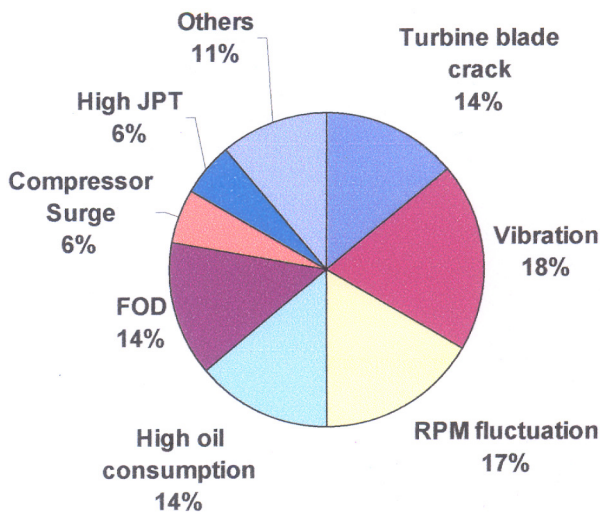
Fig.6 Number of Engines in Various Defect Categories

The defects reported for this engine are grouped in different categories such as, engine vibration, high Jet Pipe Temperature (JPT), turbine blade crack or failures, RPM fluctuation, surge etc. Number of engines withdrawn in different categories is presented in Fig.6. Some of these cases are analysed in the following sub-sections.
