## AIRCRAFT MAINTENANCE MANAGEMENT - AN ANALYSIS OF DEFECT TREND FOR MAINTENANCE OF AEROENGINE (ARTOUSTE III B)

### Abstract

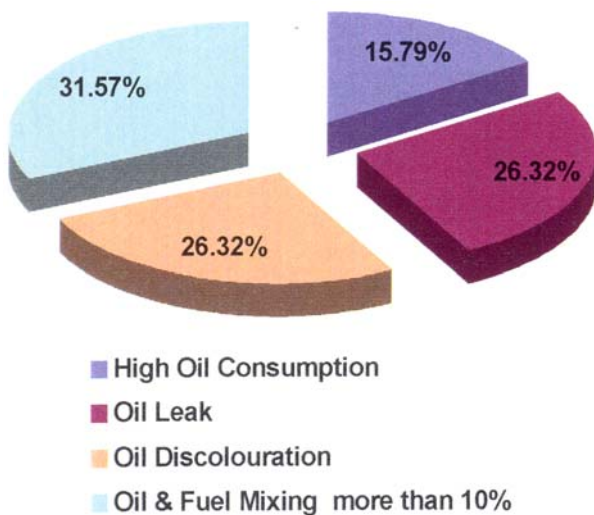
Fig.3 Nature of defects in oil system

The defects occurred in **oil system** are further classified as stated below (see Fig.3).

19 defects have occurred in oil system and the percentage of each defect works out as stated below (see Fig.3) :

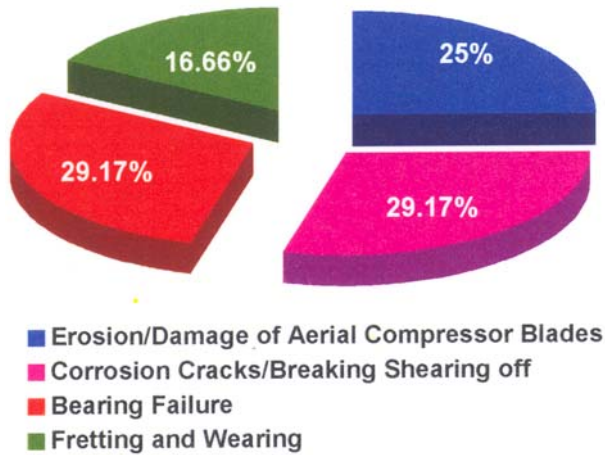
Fig.4 Nature of defects material failure

24 aero engines were prematurely withdrawn due to the defect of "**Material Failure**". Ten of them were new ones and fourteen of them were overhauled ones. This defect of material failure is further classified under the following headings (see Fig.4).

- Erosion / Damage of axial compressor blades : 6 cases
- Bearing failure / Excessive rear arm play : 7 cases
- Corrosion / Cracks / Breaking / Shearing of parts : 7 cases
- Fretting / Wearing : 4 cases

In 24 cases, the defect of '**Material Failure**' has occurred and the percentage of each category of defect is as mentioned below (see Fig.4) :

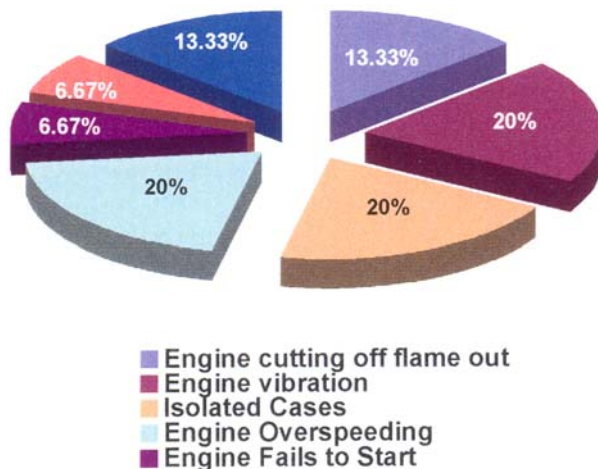
Fig.5 Miscellaneous defects

Following are the miscellaneous defects due to which fifteen aero engines were prematurely withdrawn for defect investigation (see Fig.5).

- Fuel leak : 2 cases
- RPM fluctuation : 1 case
- Engine vibration : 3 cases
- Engine cutting off/flame out : 2 cases

- Engine overspending : 3 cases
- Engine fails to start : 1 case
- Isolated cases : 3 cases

Following seven different defects have occurred in fifteen aero engines. The percentages of each defect has been studied and stated in Fig.5.

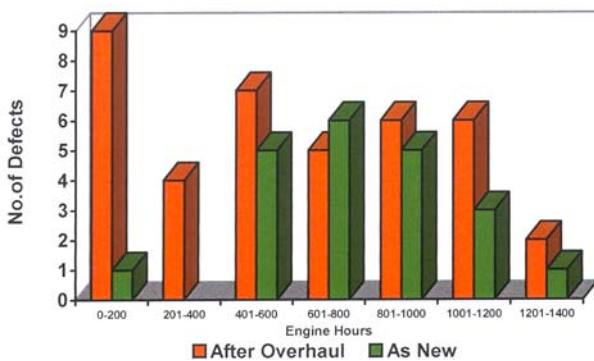
Fig.6 No. of defects vs engine hours

Defect arising against engine hours is shown in Fig.6 and the following facts are evident from the figure.

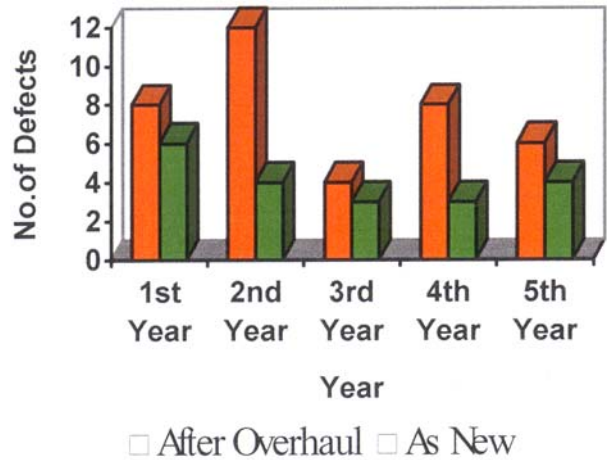
Fig.7 Calendar wise defect distribution

Calendar wise defect occurrence and its trend are shown in Figs. 7 and 8 that the defect arisings during second year is predominant. It is seen out of sixteen defects occurred in second year, twelve of them are from overhauled engines which works out to 75%. This fact points out that the overhaul lapses may be one of the major contributory factors towards defect arisings which is apparent from the trend of defects reflected in Fig.8.
