APPROACHES TO ULTRASONIC NON-DESTRUCTIVE EVALUATION OF COMPOSITES IN AIRCRAFT COMPONENTS

V. Srinivasa*, M. Ramesh Kumar*, H.N. Sudheendra* and M.R. Madhava*

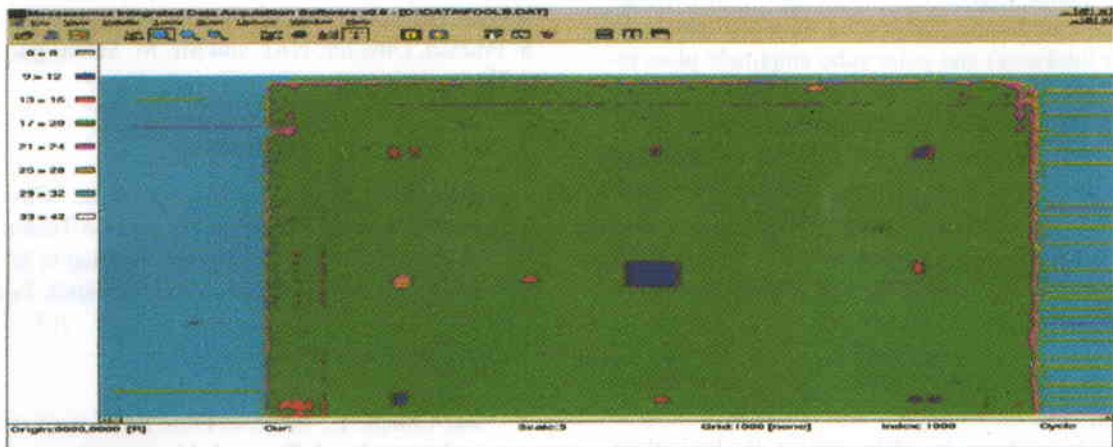
Fig. 7b Pulse echo amplitude scan

Figure 7 shows the ultrasonic C-scan inspection results obtained from the multi axes C-scan system on this sensitivity test panel. Fig.7a, 7b and 7c show the through transmission amplitude, pulse echo time-of-flight (calibrated for thickness) and pulse echo amplitude plots respectively obtained for the sensitivity test panel in a single scan. From the above C-scan plots, one can clearly see the defects, numbered 11 with bagging film as an insert and 12 having peel ply as an insert, are not detected in through transmission amplitude scan. However, Figures b & c show the presence of both these defects 11 and 12 which are clearly detected in both pulse echo amplitude and time of flight (thickness) scans.

Except for the defects 11 and 12, all the other defects are seen in both the through transmission as well as in pulse echo scans. From the above results, the limitations of through transmission inspection alone and the advantages of simultaneous acquisition of both through transmission and pulse echo information obtained from a single scan are clearly seen.
